Archaeological Monitoring and Recording  
at  
St. Columba's, Swords, Co. Dublin  
CMF24-1-DF001 Stream 1  
Licence No. 23E0752ext

## Executive Summary

A final phase of conservation works was carried out at St. Columba's, Swords, Co. Dublin in 2024. Reinstatement of floors in the belfry tower, and repairs to its roof and gutters, and re-pointing of the interior of the round tower completed the necessary conservation measures for this site.

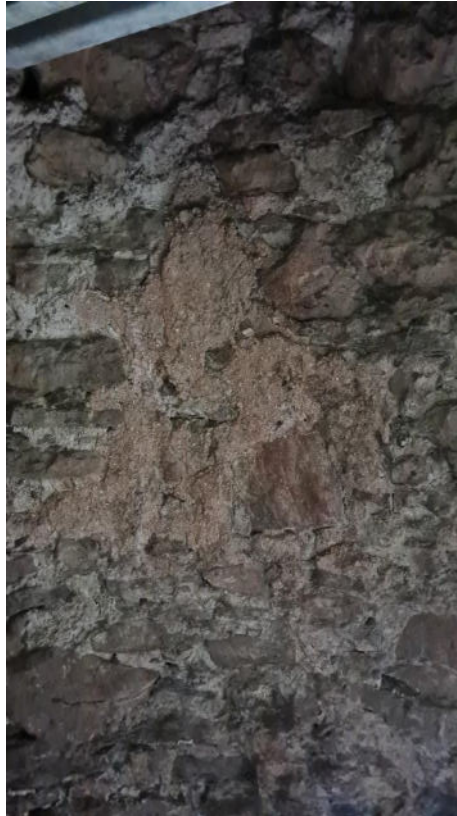
Plate 1: Wall in Floor 1, entrance, retaining pointing and possible plaster of unknown date

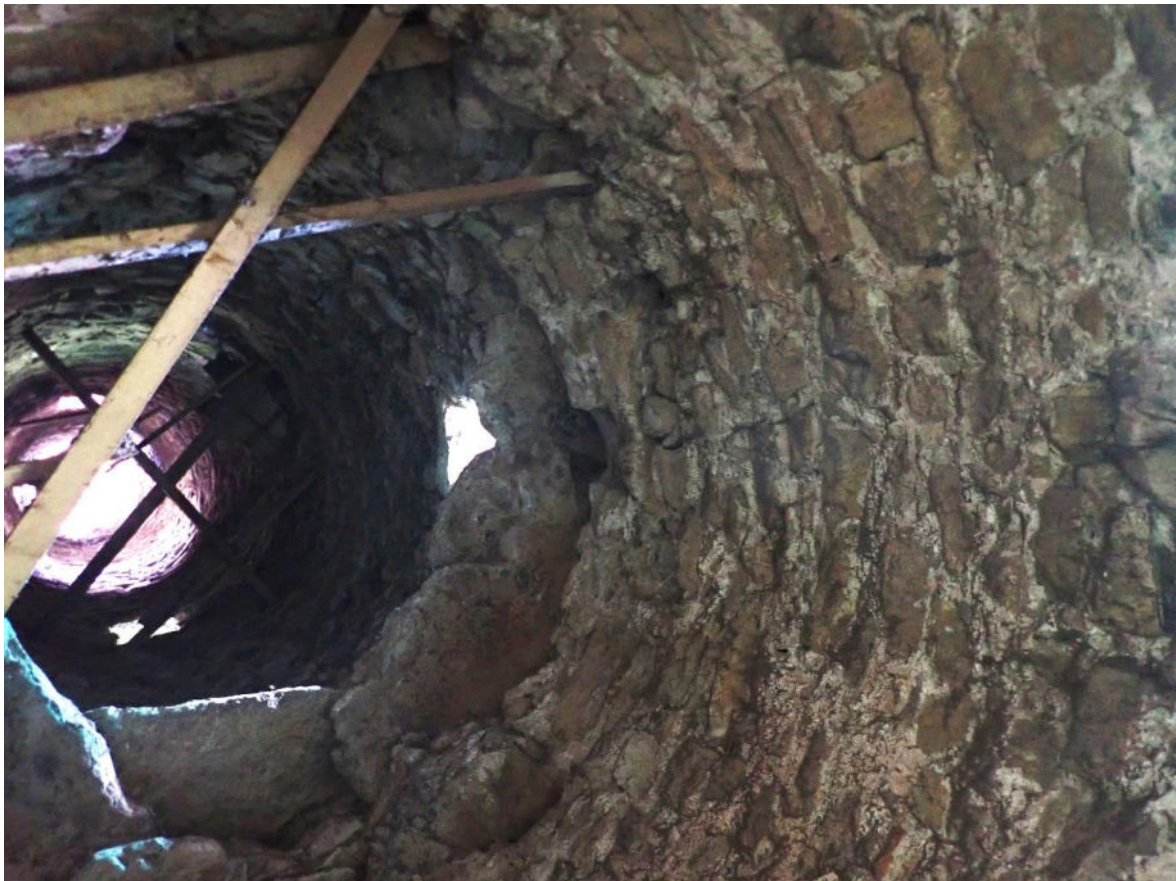
Plate 2: Looking up towards underside of corbelled stones which have protected the mortar from weathering. Taken in 2023 before the beams were removed.

Residual holes, possibly from wooden beams inserted sometime in the last few hundred years, were noted beneath the corbels, but not further down, but as they are similar to holes in the walls above the corbels where beams were not used and they do not appear to be the result of deterioration, another explanation for them is needed.

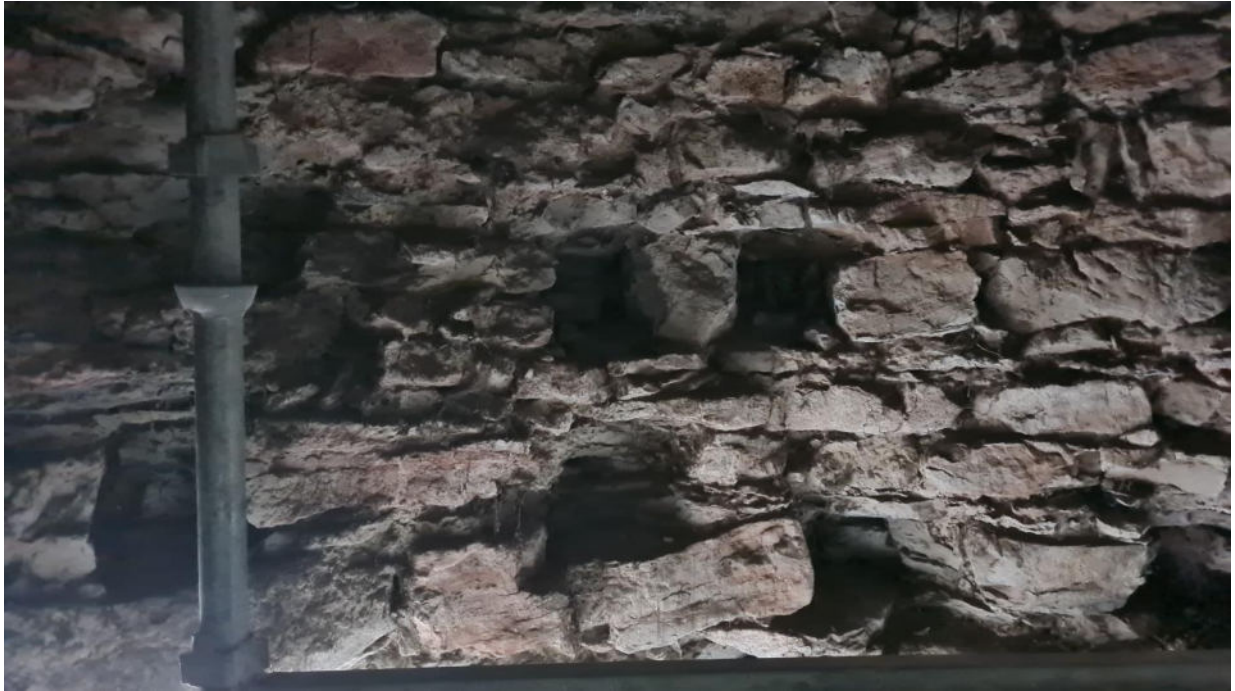
There was considerable mortar loss noted at this level. It is lit by a large, east facing window, 1.03m high. The windowsill is at the same level as the corbelled stones. At least seven of these form a ring jutting out from the wall, alternately overlapping and running beneath each other (see Plate 2). Some of the corbels appear damaged and truncated along the south side of the tower and this may relate to the late 17<sup>th</sup> century work carried out during the improvement works at St Columba's attributed to Rev. Scardeville. A significant number of missing stones were noted in the wall, especially along the west and south sides and their seeming regularity was striking. It is possible that they formed a columbarium at some point in the life of the tower, so they were not filled in except where additional stone was deemed necessary to provide support to overhead stones.

Plate 3: Holes occurring just above the level of the corbels, south side. Note mortar loss.

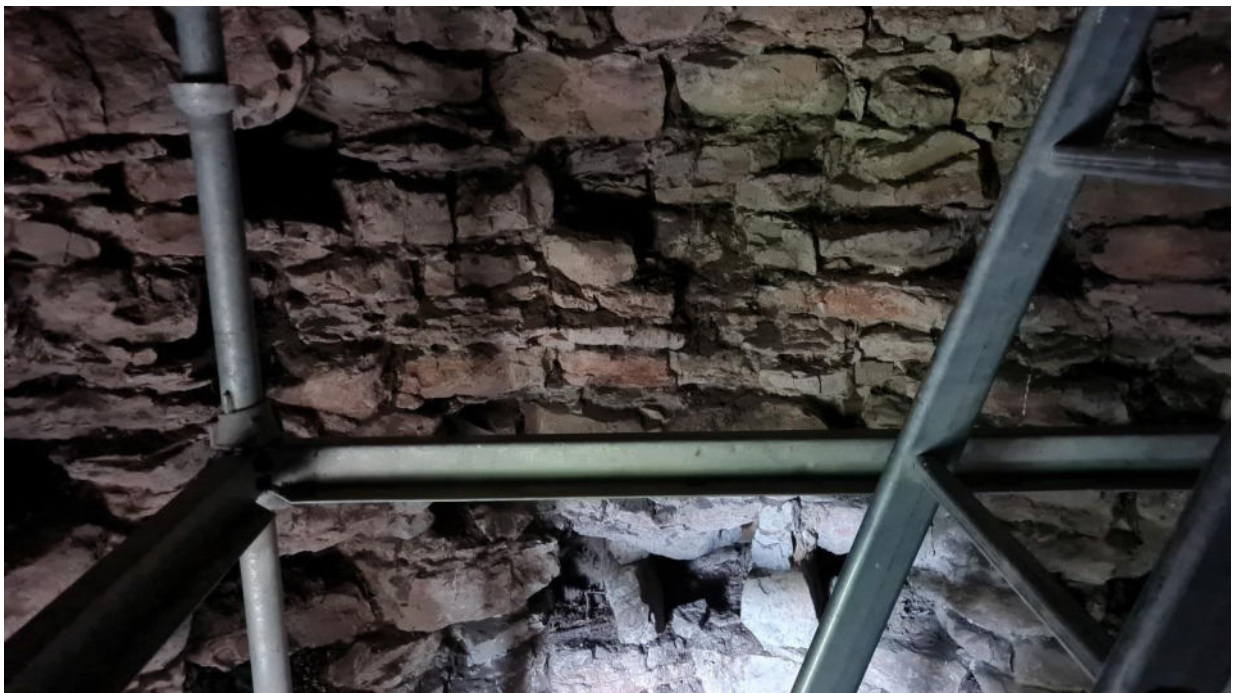
Plate 4: Holes in the wall, west side, above the level of the corbels

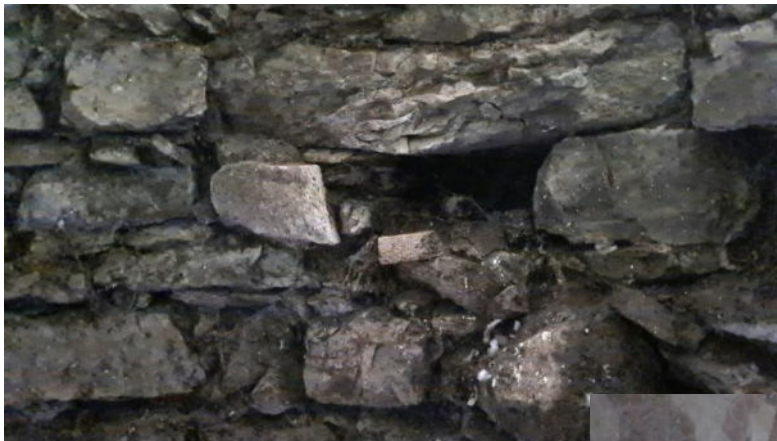
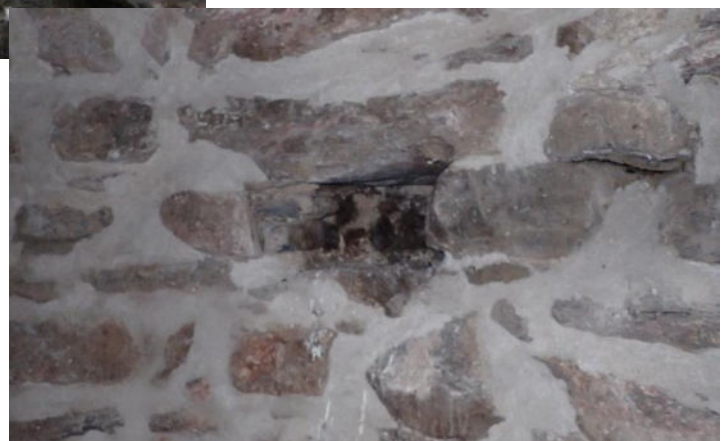
Plate 5: Beam hole 1, before and after re-pointing

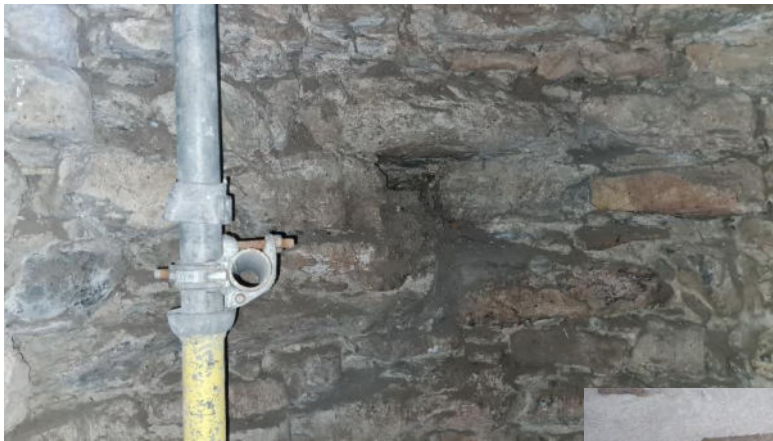
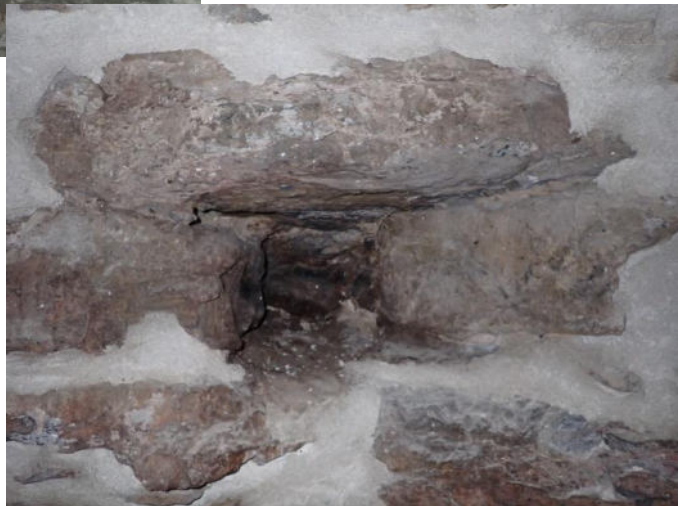
Plate 6: Beam hole 2 before and after re-pointing

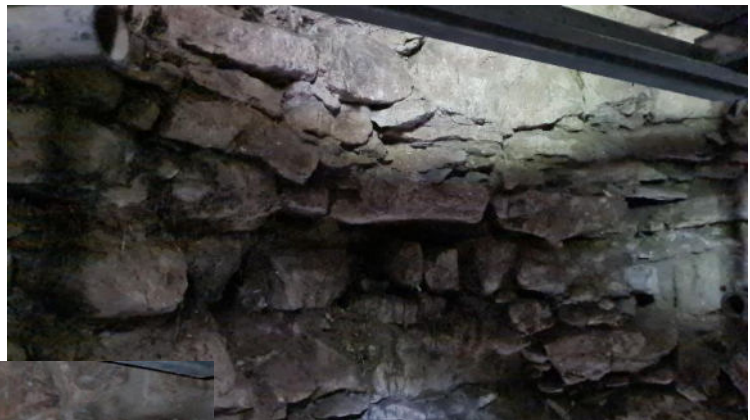
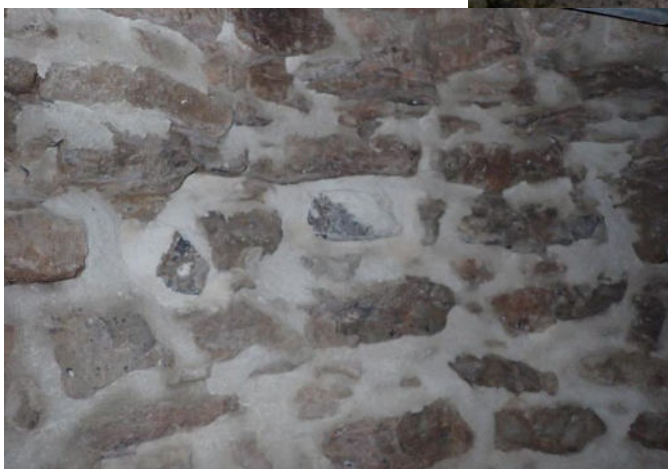
Plate 7: Beam hole 3 before and after re-pointing; stones were in the hole, and they were mortared in position in error.

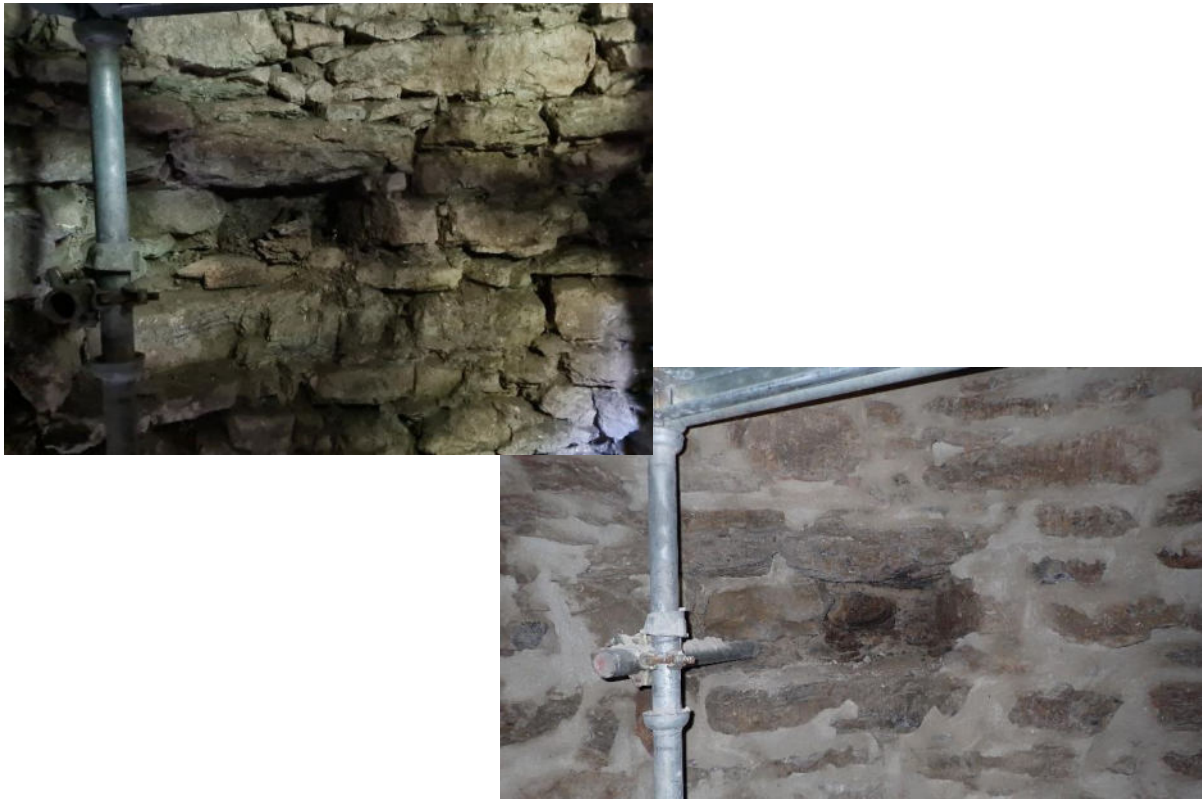
Plate 8: Beam hole 4 before and after re-pointing.

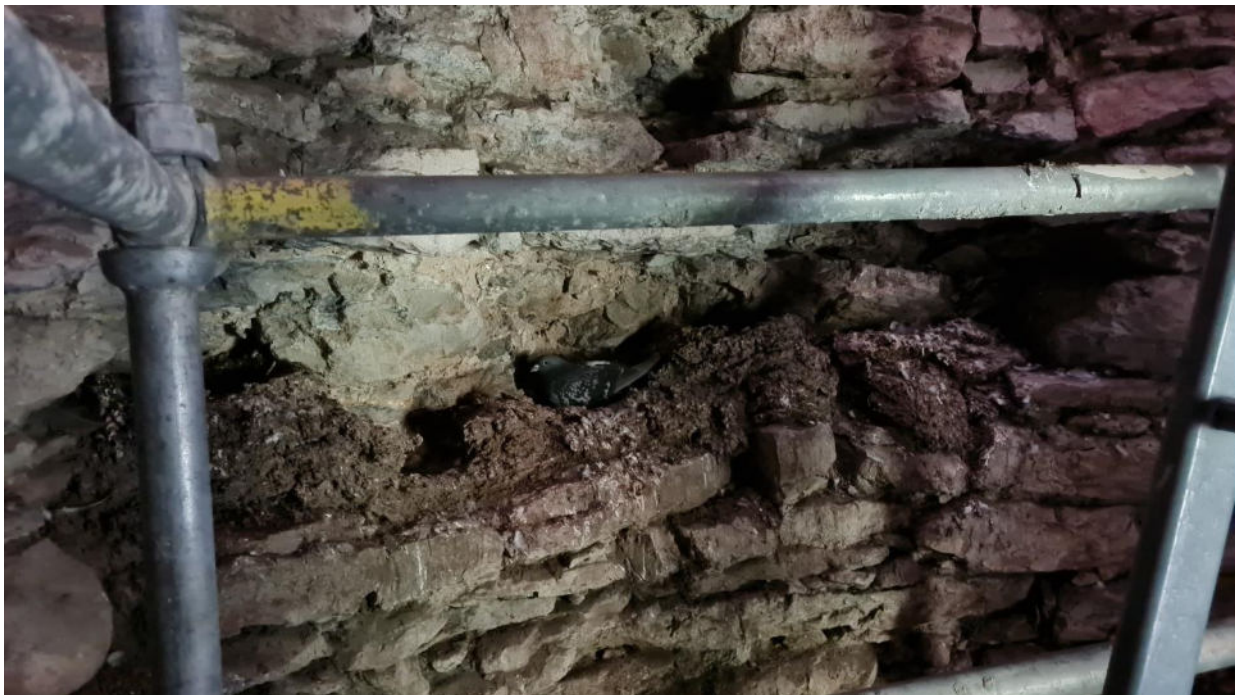
Plate 9: Stone loss resulting in ledges at the same level as the beam holes, note pigeons and nesting material

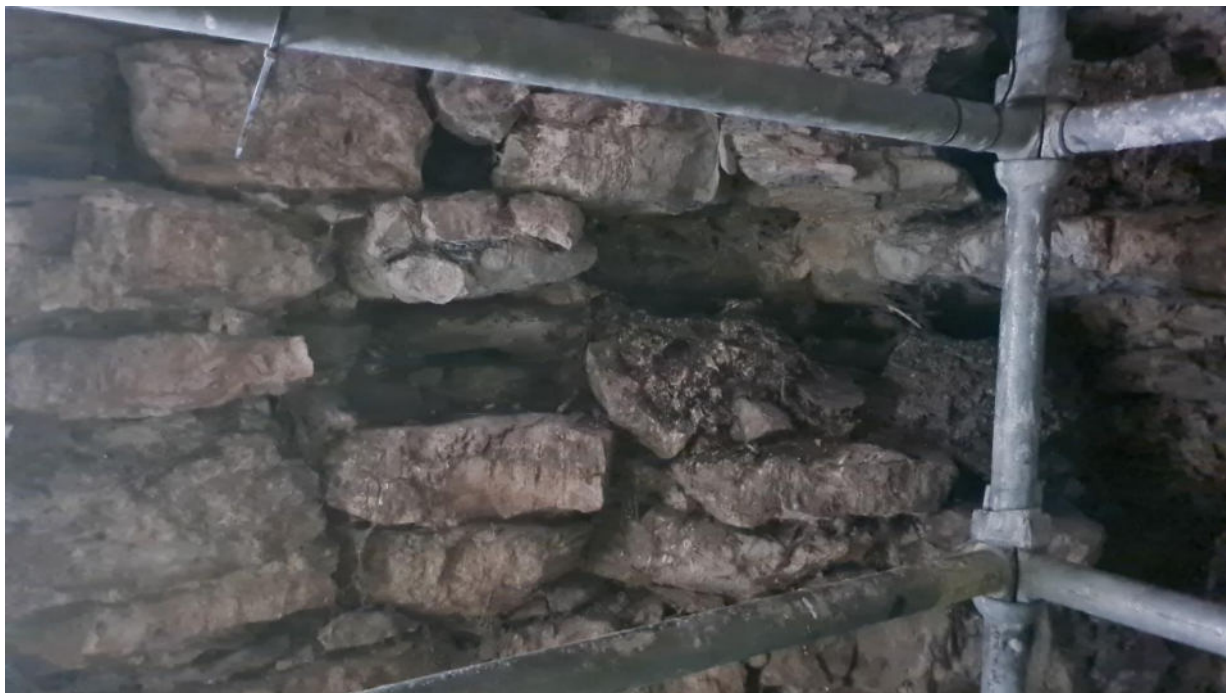
Plate 10: Stone loss on the east side. Possibly caused by the insertion of later wooden beams, now removed.

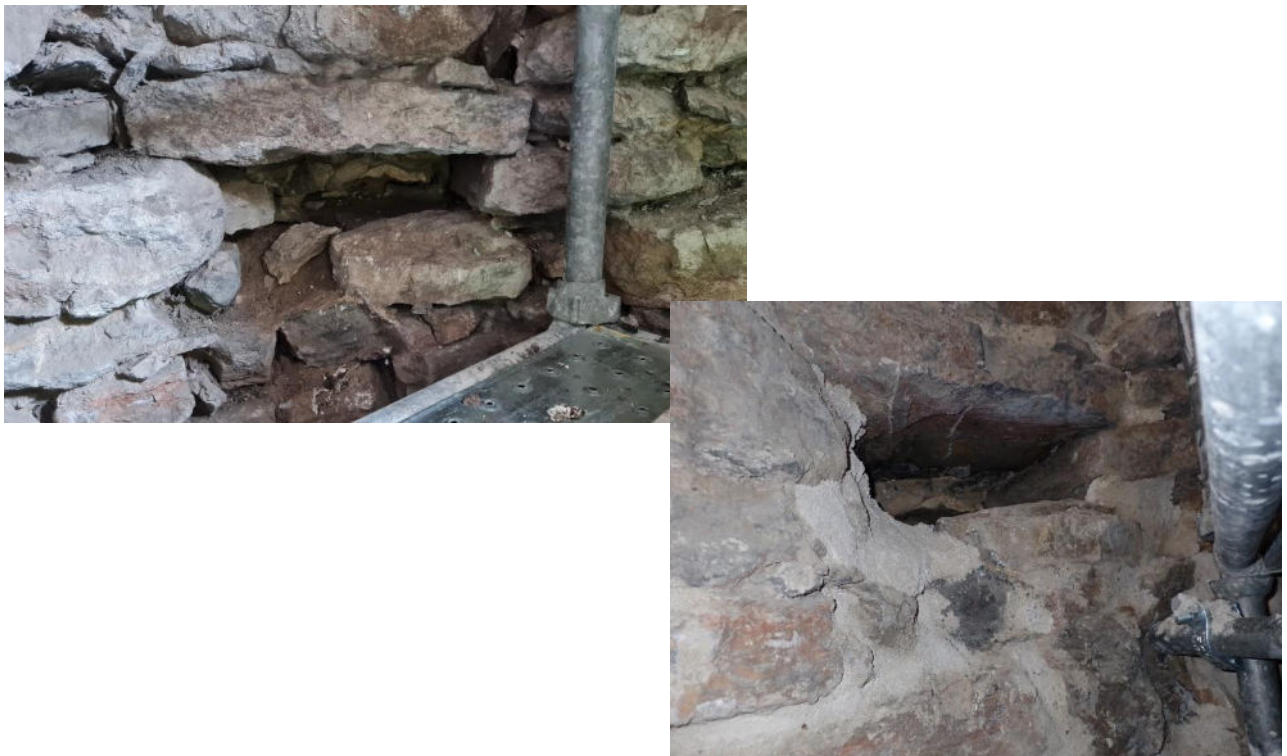
Plate 11: Beam hole 3 before and after re-pointing

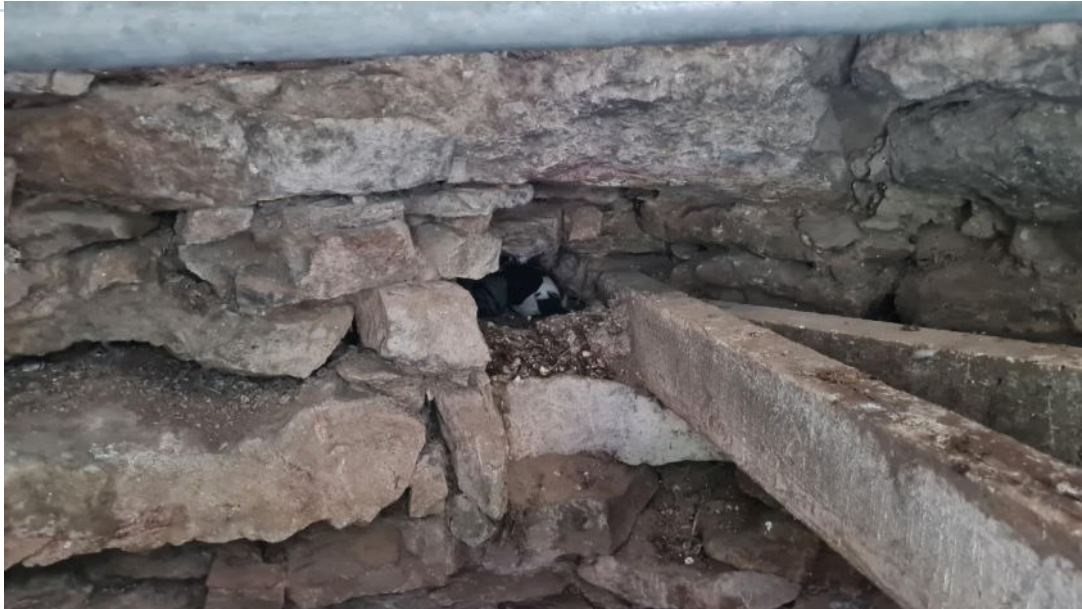
Plate 12: Beam hole 4 with pigeons in situ on build-up of soil and droppings, and two wooden beams inserted into it

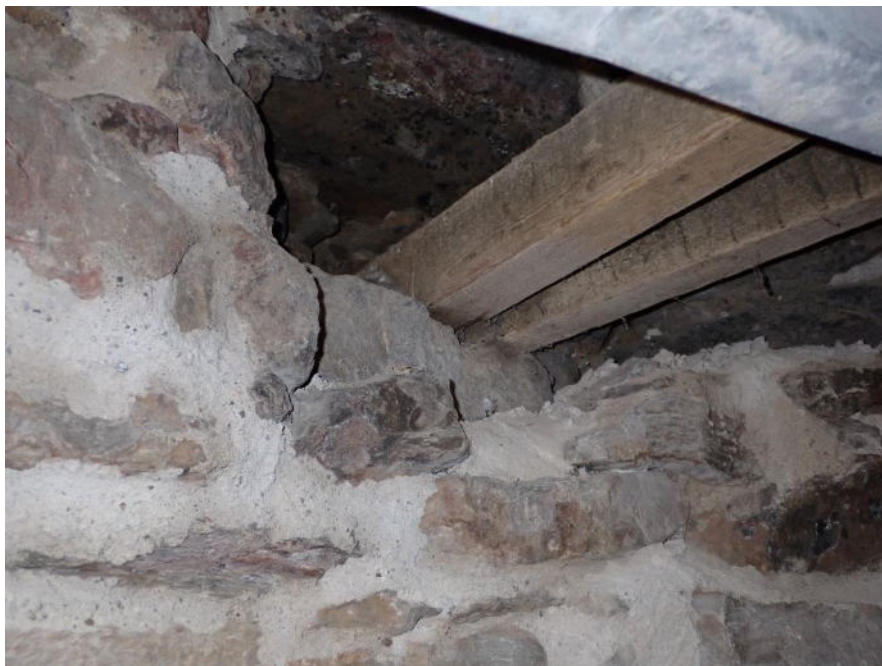
Plate 13: Beam hole 4 after re-pointing but with the wooden beams still in position

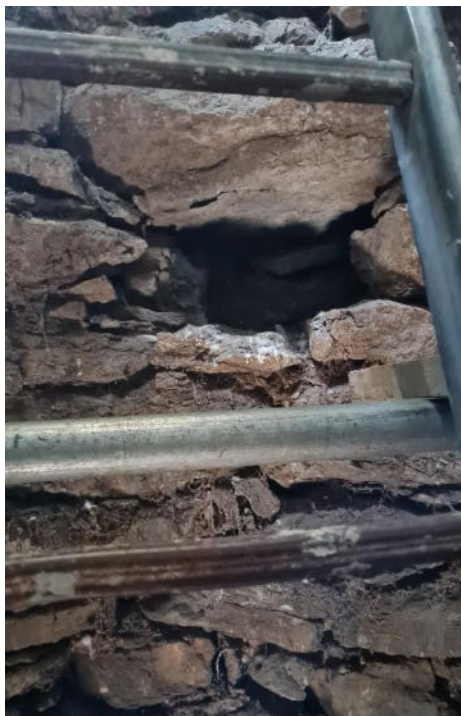
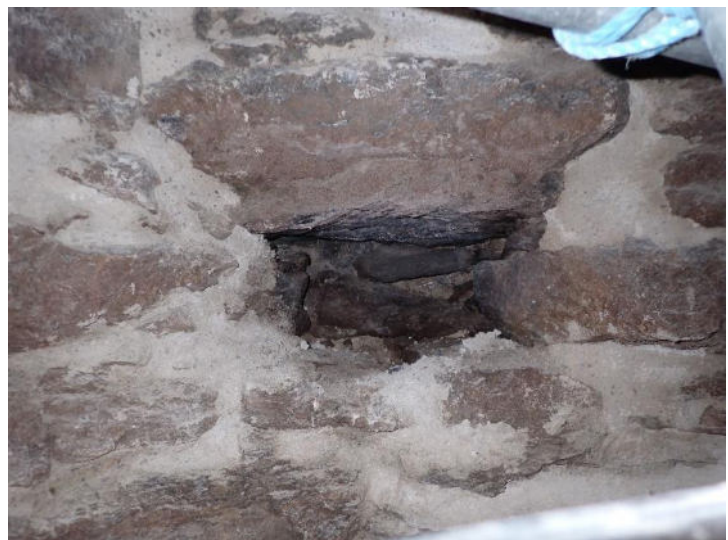
Plate 14: Beam hole 1 before and after re-pointing

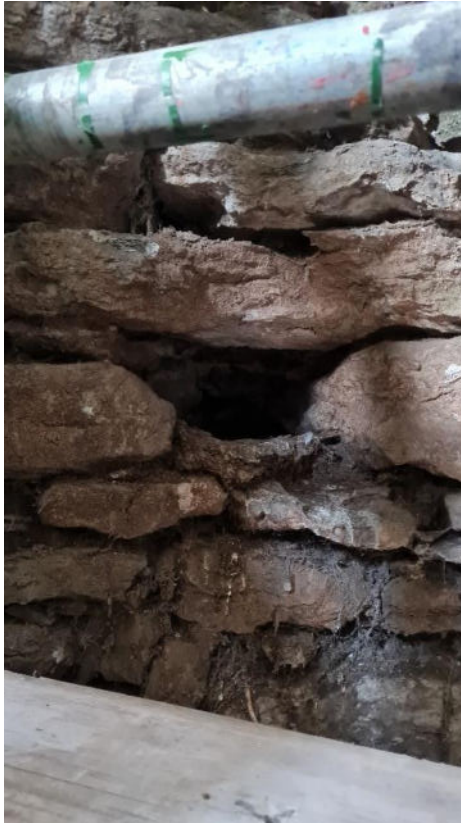
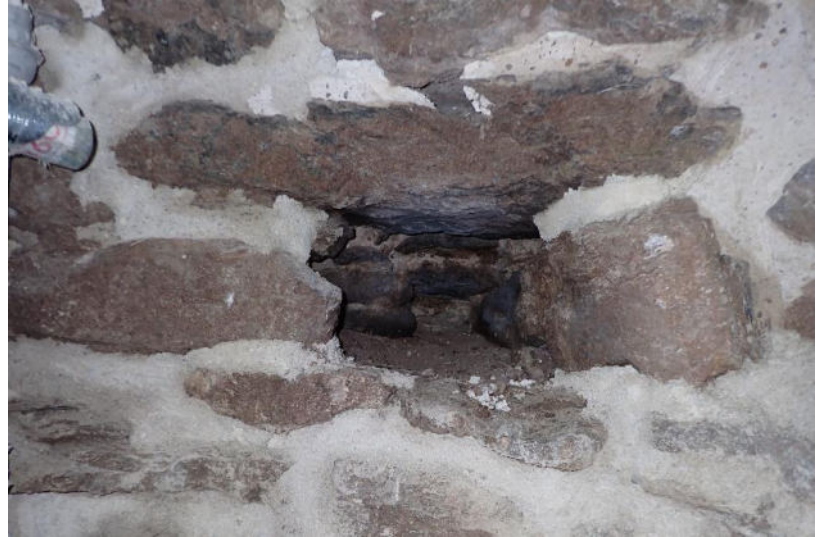
Plate 15: Beam hole 3 before and after re-pointing

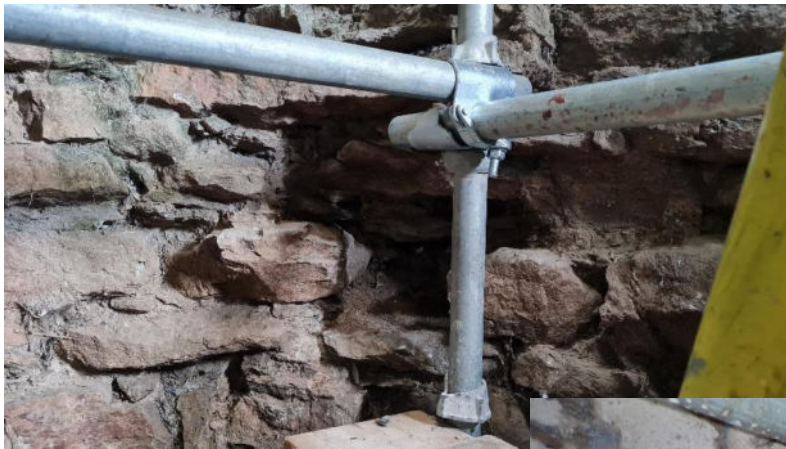
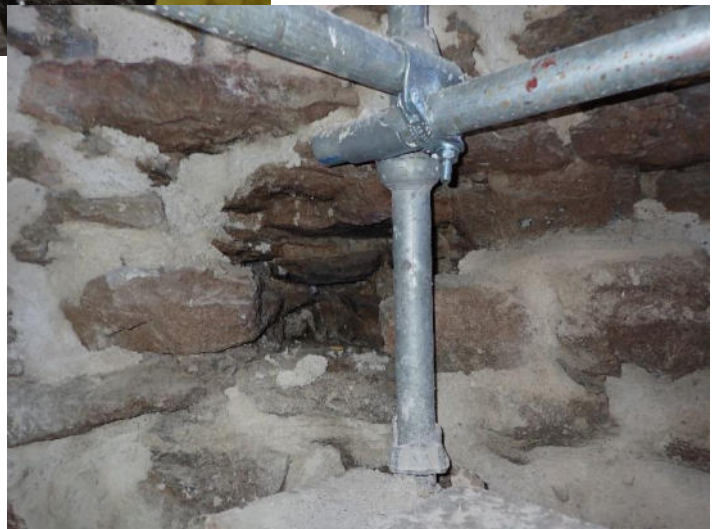
Plate 16: Beam hole 4 before and after re-pointing

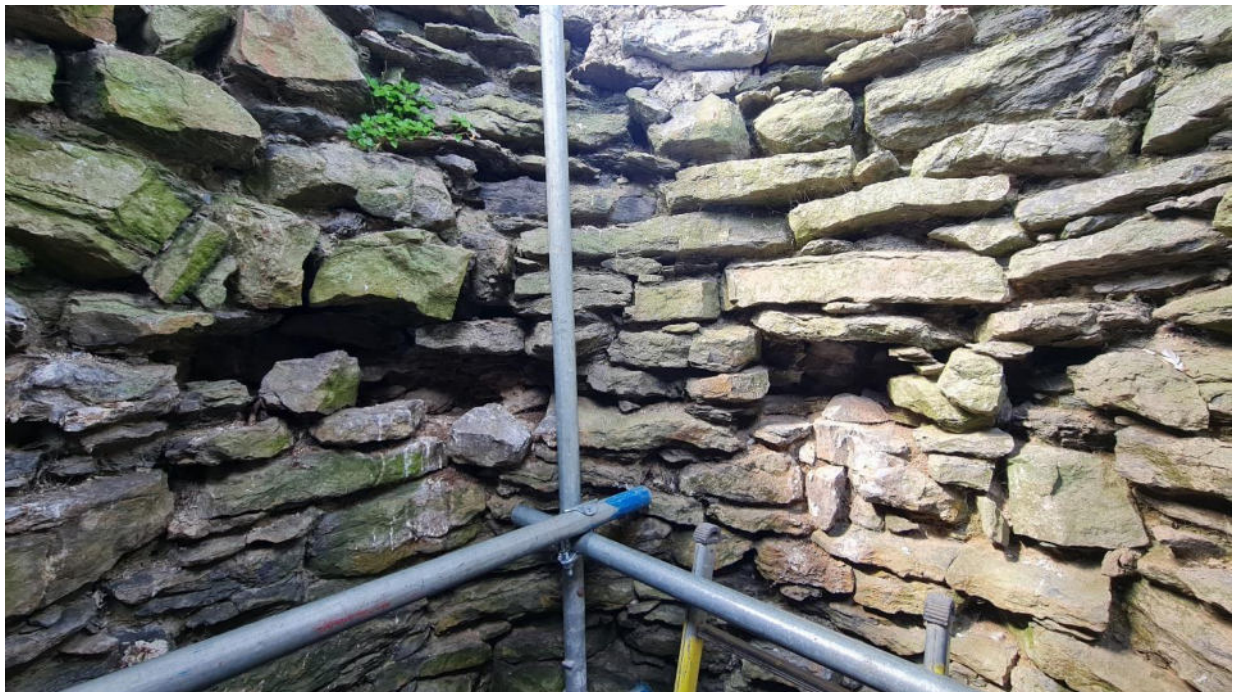
Plate 17: Beam holes 2 (left) and 1 (right) before re-pointing. The distance between them is 1.50m centre to centre, but the wide-angle view distorts this somewhat.

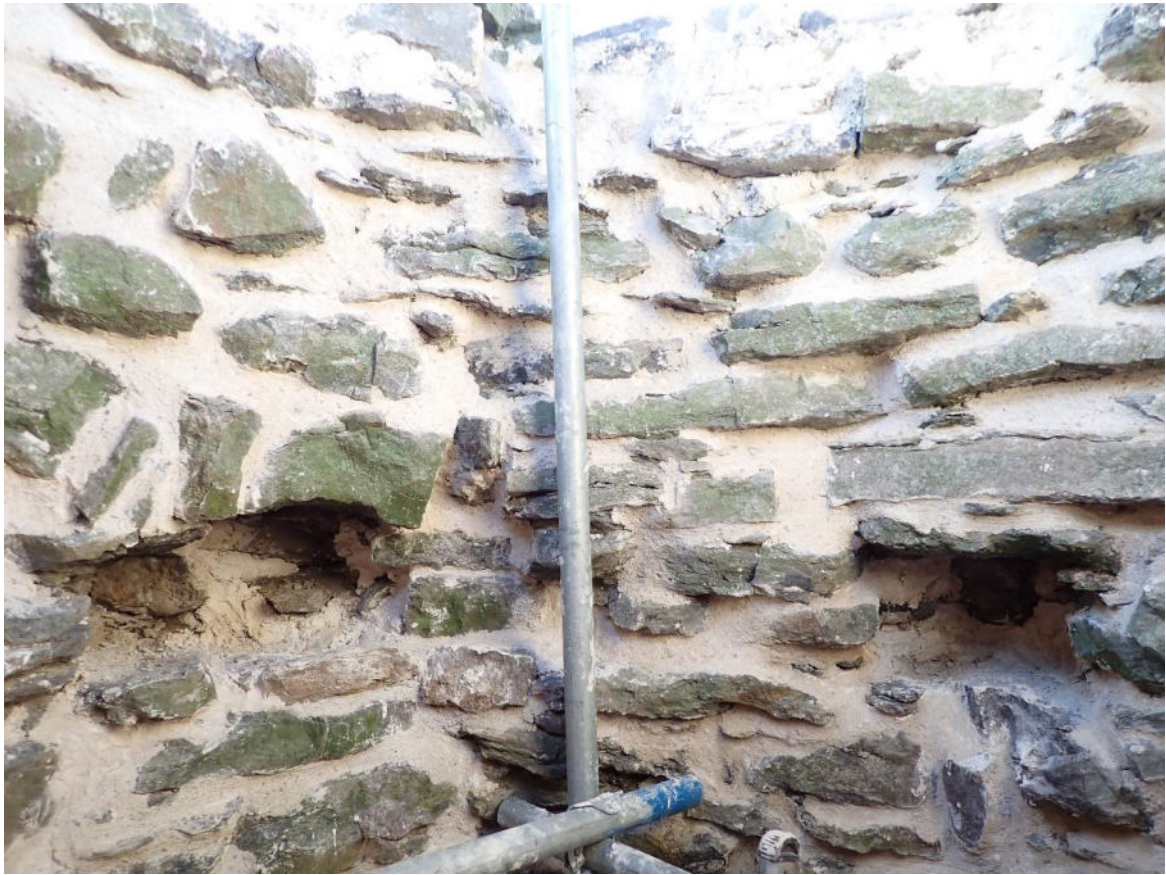
Plate 18: The same beam holes, 2 and 1, after re-pointing.

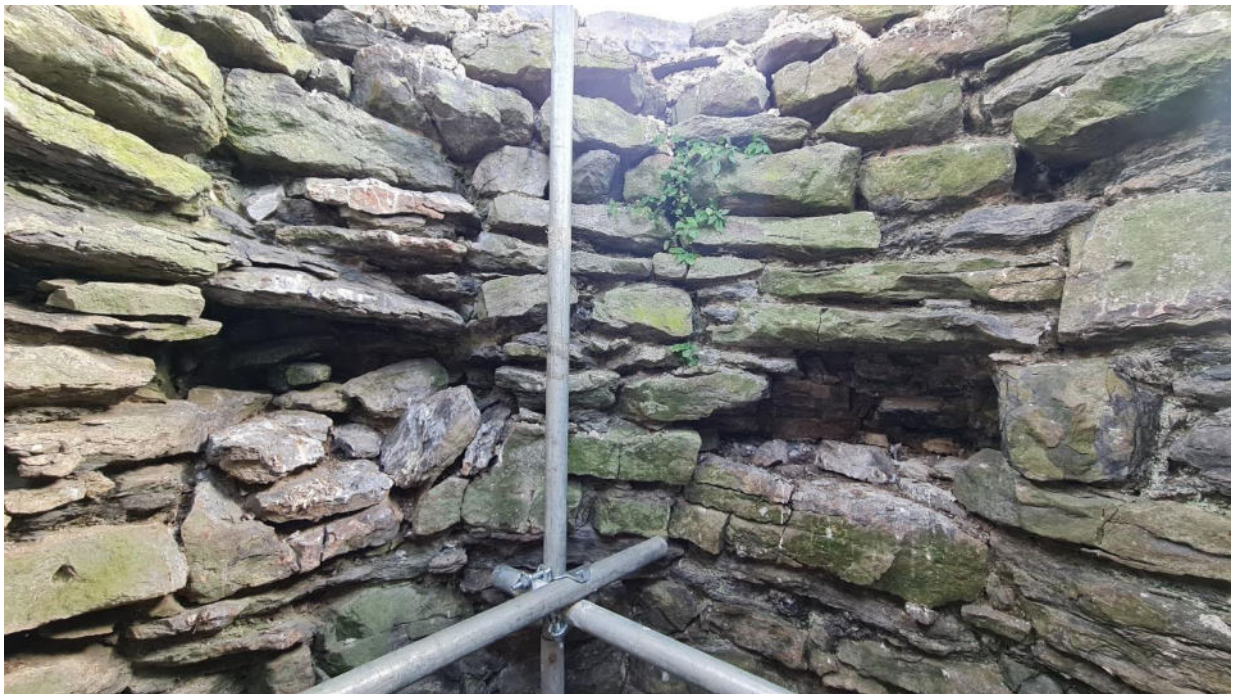
Plate 19: Beam holes 4 (left) and 3 (right), before re-pointing. The distance between these is 1.40m.

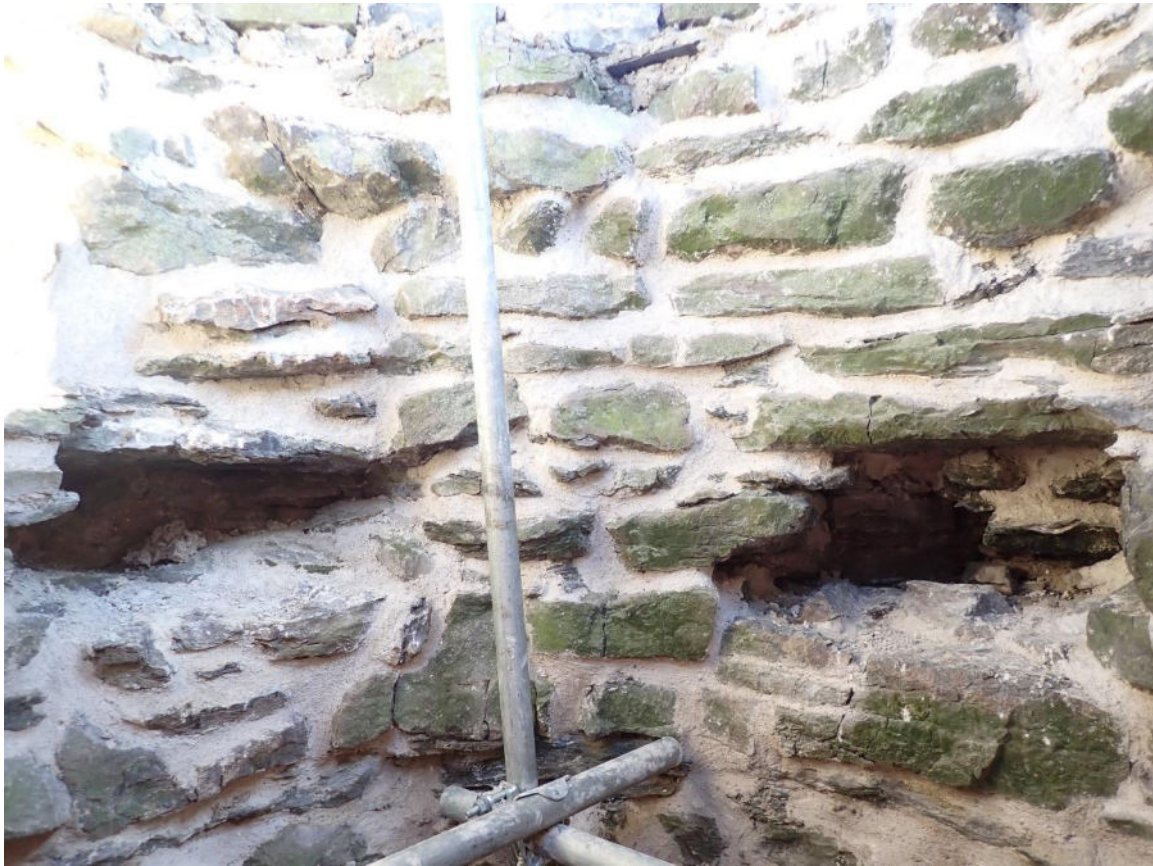
Plate 20: Beam holes 4 and 3 after re-pointing.

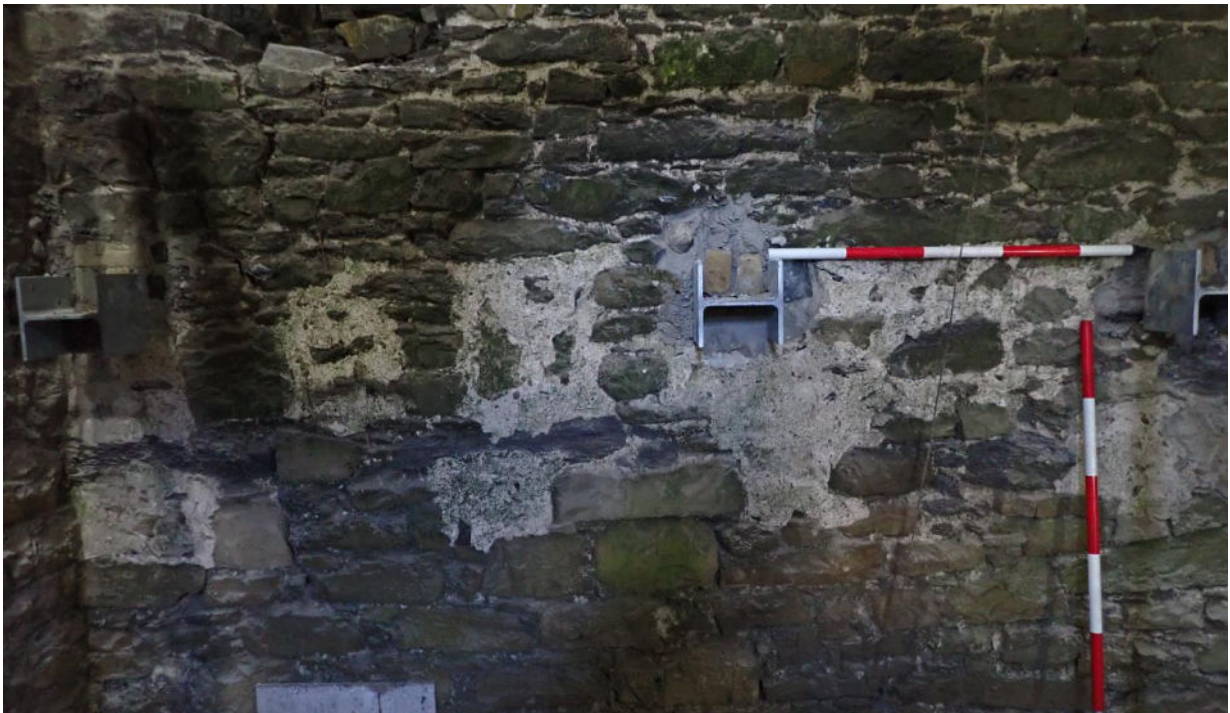
The floor joists for the second floor were to be supported on steel brackets. These were inserted without archaeological supervision and the probable original locations of the joist sockets were not used as the joists were placed to reflect the position of the corbels on the floor above. There were no visible sockets or holes in the walls, but in the east and west walls there were areas that clearly had been filled in with mortar and small stones. Several of these which were reasonably regularly spaced had lintel-like stones spanning the tops and would appear to be original joist holes or sockets.

Plate 22: First floor east wall with H-brackets inserted from the NE (left side) corner to centre. Note the lintel-like stones in the centre and above the horizontal ranging rod

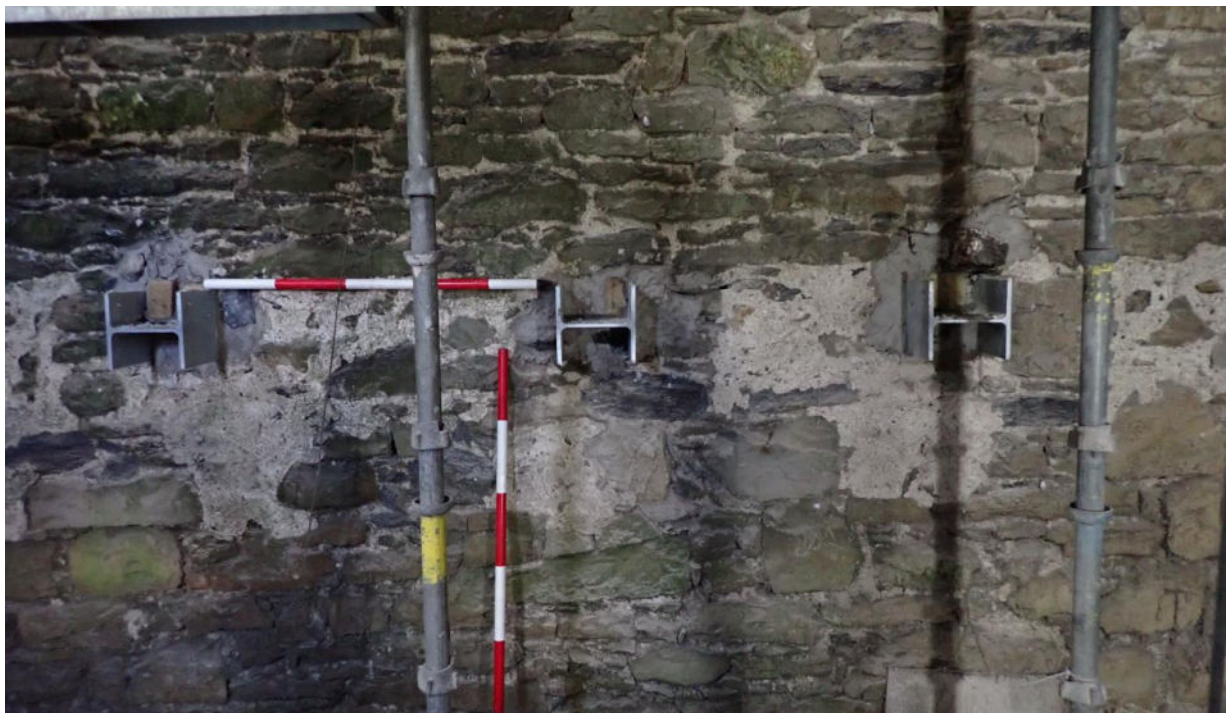
Plate 23: First floor east wall with H-brackets, centre to SE side. Again, note lintel-like stones above the areas with mortar and stone.

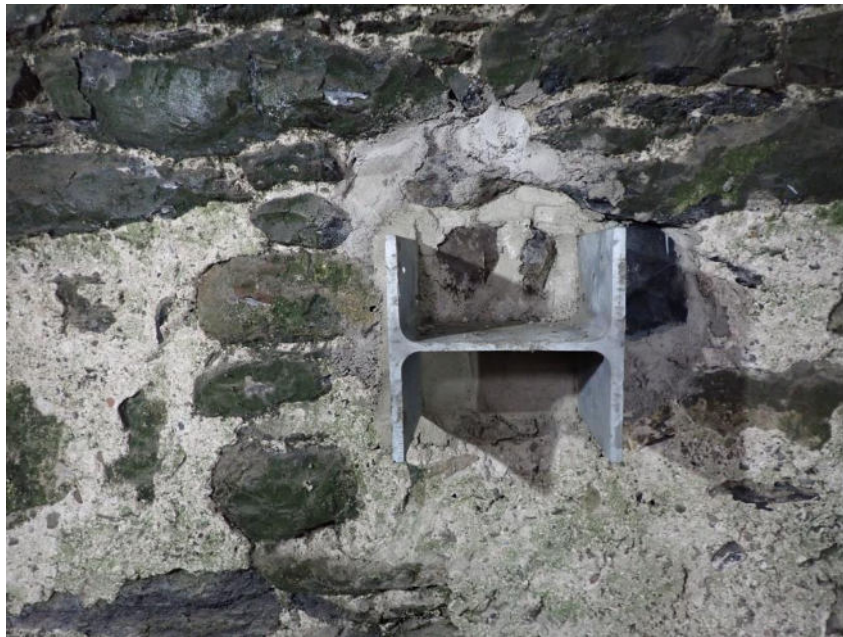
When the brackets were inserted, the holes created to do so were initially filled with bricks and mortar. The bricks were deemed to be unsuitable and were replaced with stones.

Plate 26: Stone replacing the brick infilling of the holes around the brackets.

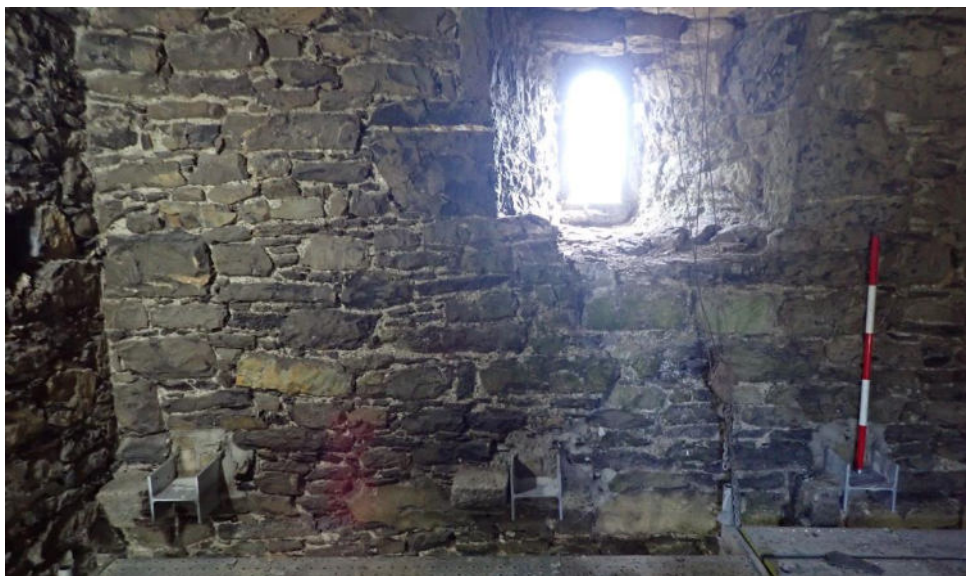
Projecting stone corbels on the east and west walls were the original supports for the floor at this level. H-brackets were inserted alongside each corbel in error, but were subsequently removed and a beam to support the floor run along the top of the corbels on each wall.

Plate 27: H-brackets positioned beside the corbels, east wall.

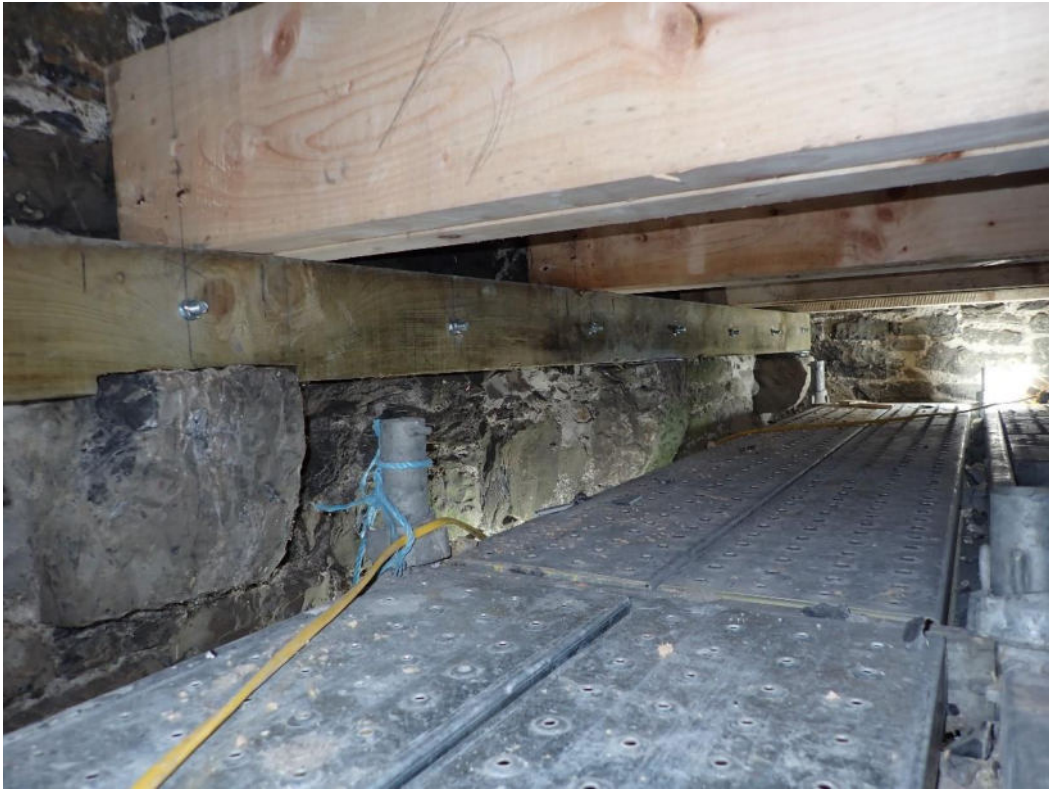
The corbels were not perfectly level, so some adjustments had to be made to the beam to allow for that.

Plate 28: Detail of beam on corbels, west wall, with floor joists above.

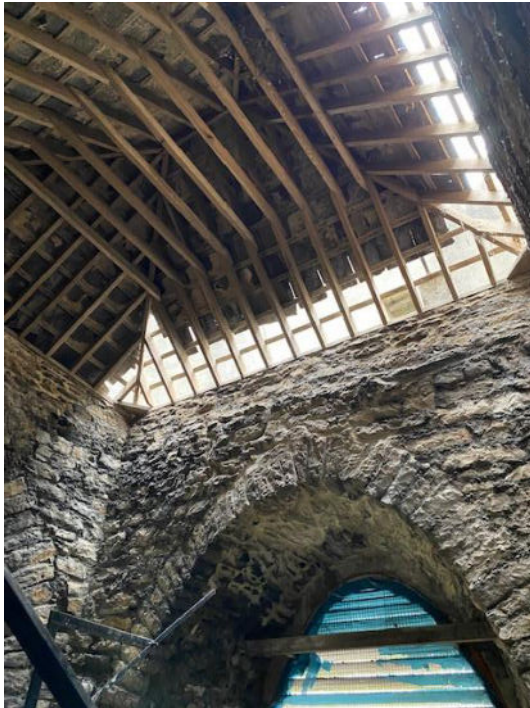
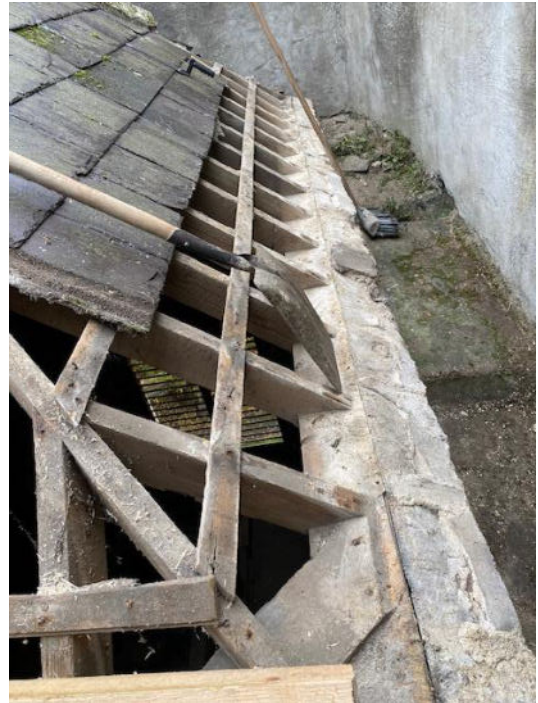
As slates on the roof were cracking or broken, they were stripped off and replaced, using the original slates as much as possible, but replacing damaged ones with matching new slates. A new gutter and spout to manage rainwater run-off is being installed also.

Plates 30-31: Beginning to strip the slates from the roof

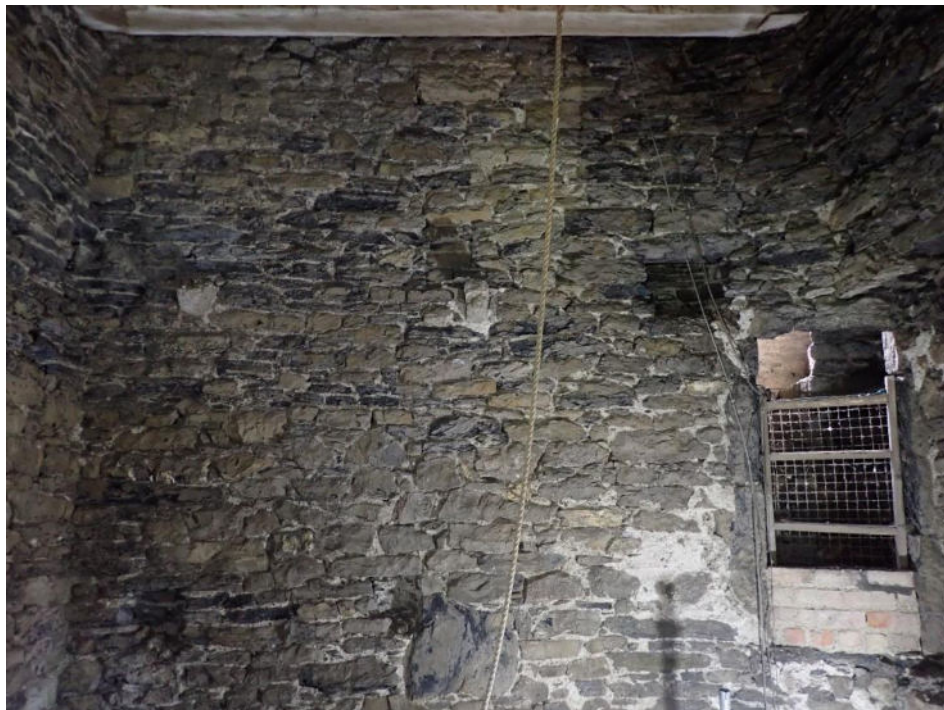
In the interior of the tower a row of corbels on the south wall, with apparently matching joist sockets on the north wall were noted between the third floor and the bell floor level. Putlog holes were also noted on the east wall (Figure 3, Second floor plan) and north wall.

Plate 36: View of south wall with two corbels and one socket below the bell floor level
