Archaeological Monitoring and Recording  
at  
St. Columba's, Swords, Co. Dublin  
CMF24-1-DF001 Stream 1  
Licence No. 23E0752ext

## Executive Summary

A final phase of conservation works was carried out at St. Columba's, Swords, Co. Dublin in 2024. Reinstatement of floors in the belfry tower, and repairs to its roof and gutters, and re-pointing of the interior of the round tower completed the necessary conservation measures for this site.

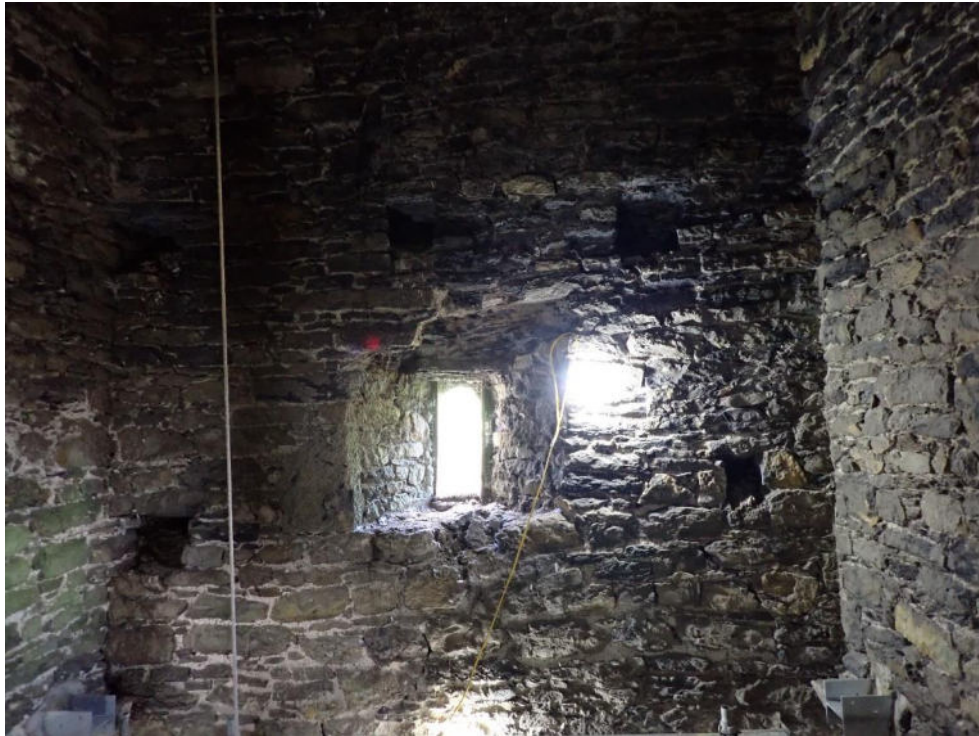
Plate 37: View of the north wall with joist sockets above the window level, below the bell floor. Note the possible putlog holes lower down.

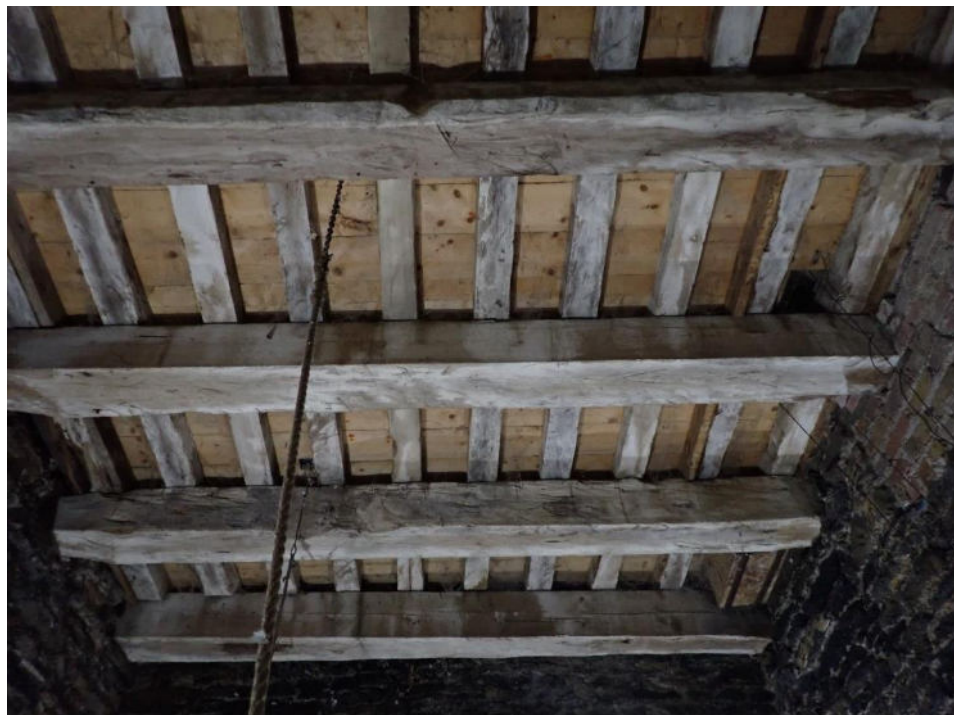
The drop from the surface of these corbels/joist sockets to the top of the corbels beneath is 2.45m (see Figure 3 third floor plan). Looking at the underside of the bell floor and the east wall, there is an area infilled with brick through which a joist for the floor goes.

Plate 38: Underside of bell floor with east wall showing brick infill
