Drynam Heath Quiet Street, Kinsealy
Stage 1 Road Safety Audit

Fingal County Council

March 2025

Stage 1 Road Safety Audit

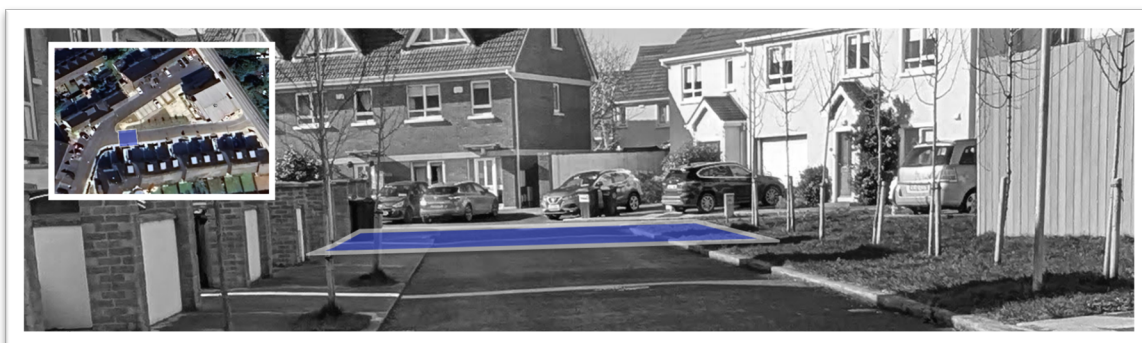
Figure 2.1 – Location Where Suitable Signs & Lines Should Be Provided Highlighting Cul de Sac

2.1 Problem: Missing Cul de Sac Signs

Location: Junction of Drynam Heath & Drynam Green

Failing to alert incoming drivers that Drynam Heath is not a through-as road could lead to sudden braking on approach to the bollards and extended (risky) reversing manoeuvres.

Recommendation

Suitable signage should be provided at the entry point to Drynam Heath to inform drivers that the street operates as a Cul de Sac.

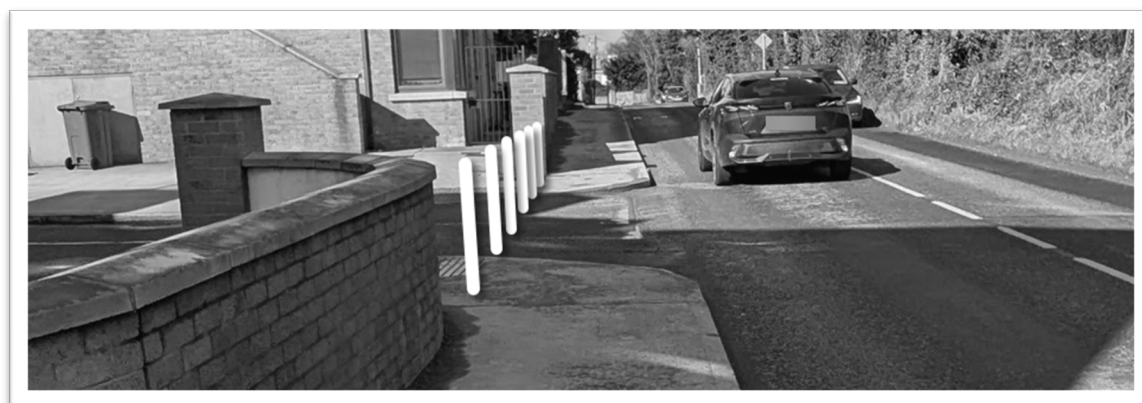
Figure 2.2 – Indicative Bollards Alignment on Feltrim Road Leading to Pedestrian Strikes

2.2 Problem: Pedestrian Strikes on Traffic Bollards

Location: Pedestrian Crossing at Junction of Drynam Heath & Feltrim Road

The proposed alignment of the bollards could lead to pedestrian strikes and progression issues for mobility impaired road users (especially the blind or partially sighted) wishing to access the courtesy crossing.

Recommendation

The position of the bollards should be adjusted to facilitate universal access to the courtesy crossing (i.e. especially mobility impaired pedestrians).

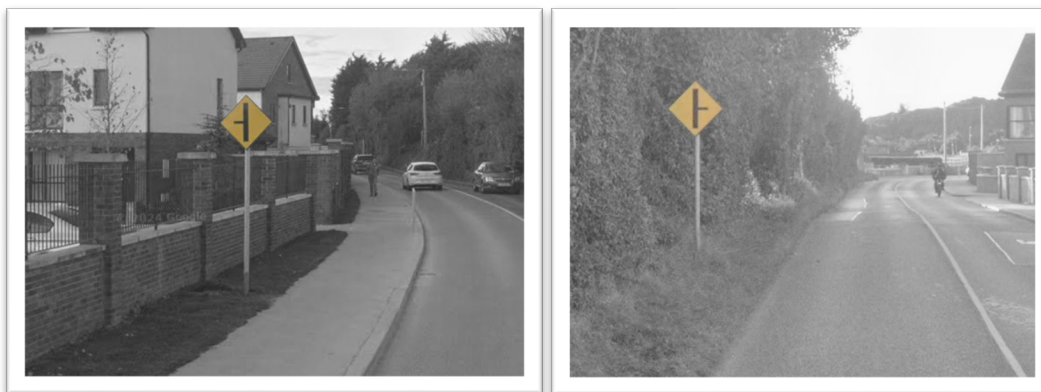
Figure 2.3 – Junction Ahead Warning Signs Causing Confusion for Drivers

2.3 Problem: Existing Junction Ahead Warning Signs

Location: Feltrim Road – Northbound & Southbound Approaches to Drynam Heath

The existing junction ahead warning signs could lead to driver confusion and vehicle strikes on the bollards. Especially during low light conditions.

Recommendation

The junction ahead warning signs should be removed, and the traffic bollards should be fitted with suitable reflectors.
