Archaeological Monitoring and Recording  
at  
St. Columba's, Swords, Co. Dublin  
CMF24-1-DF001 Stream 1  
Licence No. 23E0752ext

## Executive Summary

A final phase of conservation works was carried out at St. Columba's, Swords, Co. Dublin in 2024. Reinstatement of floors in the belfry tower, and repairs to its roof and gutters, and re-pointing of the interior of the round tower completed the necessary conservation measures for this site.

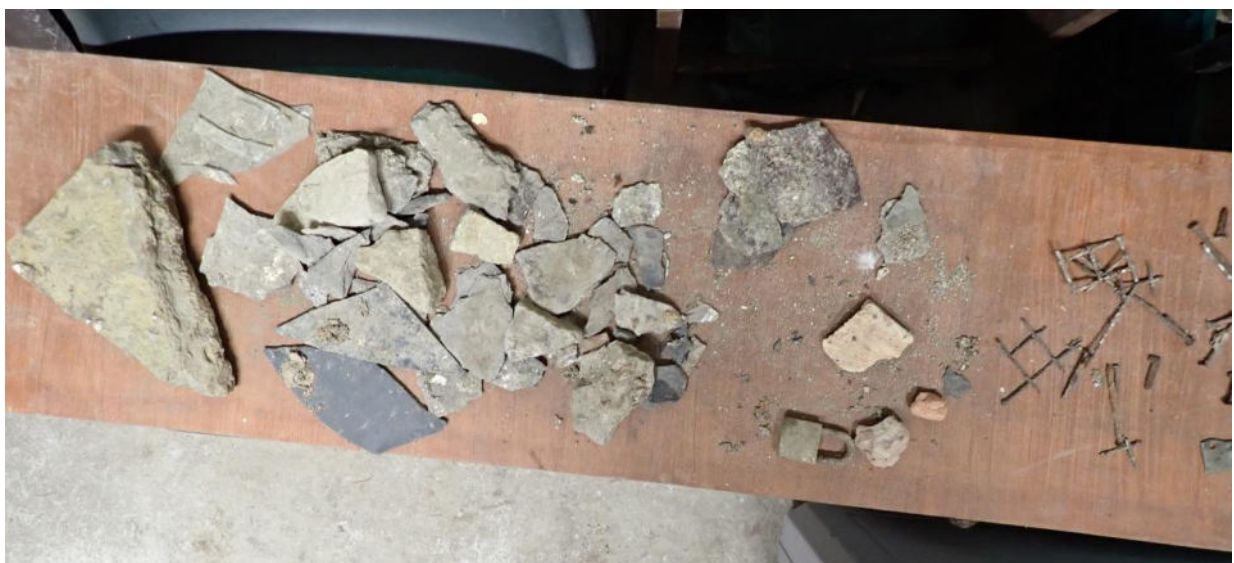
Floors were reinstated on the second and third floor levels. Prior to putting in the scaffolding the debris that had accumulated on the first floor was removed. This was examined to see if it contained any archaeological material with the assistance of Szymon Mierocha, groundsman at St. Columba's. All the finds proved to be modern, and pieces of slate and mortar were also recovered.

Plate 21: Selection of material recovered from above the vault.

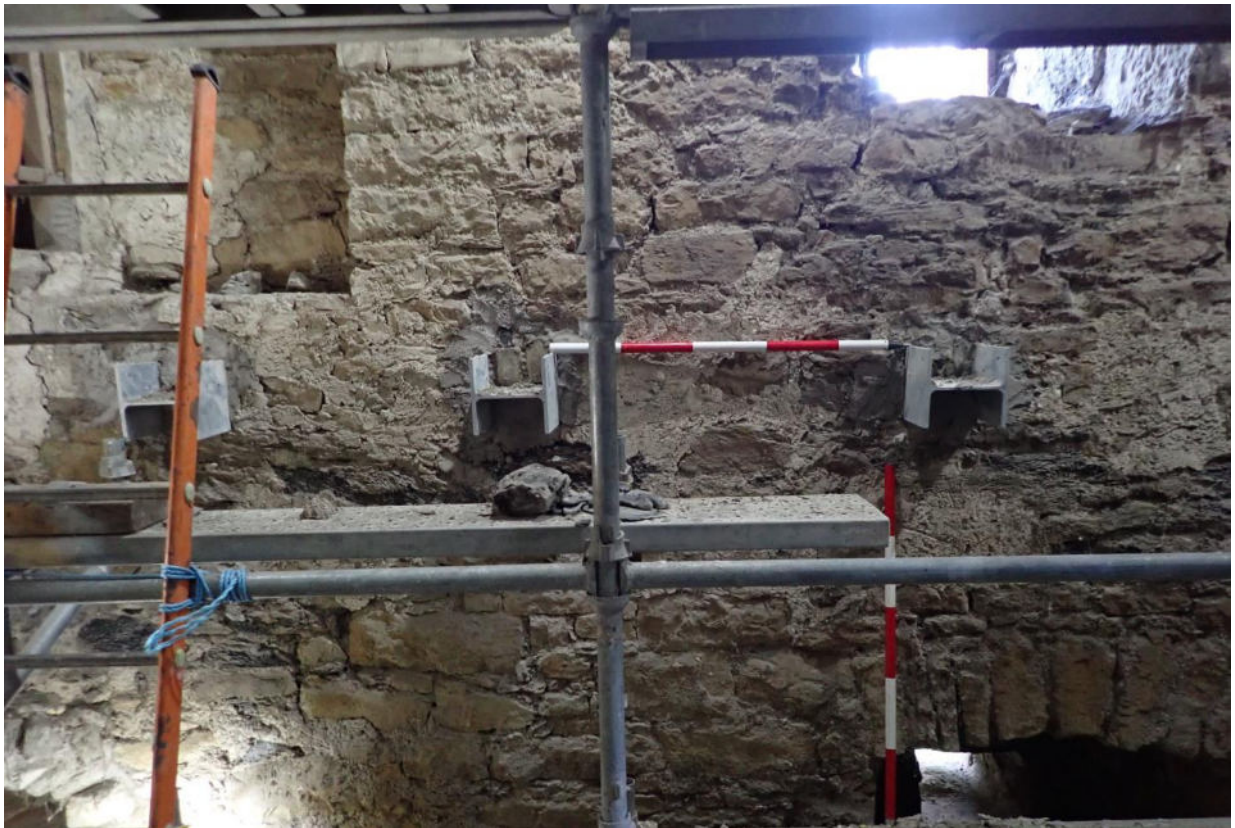
When the brackets were inserted, the holes created to do so were initially filled with bricks and mortar. The bricks were deemed to be unsuitable and were replaced with stones.

Plate 24: Second floor, west wall, brackets from SW corner at the door to the centre.

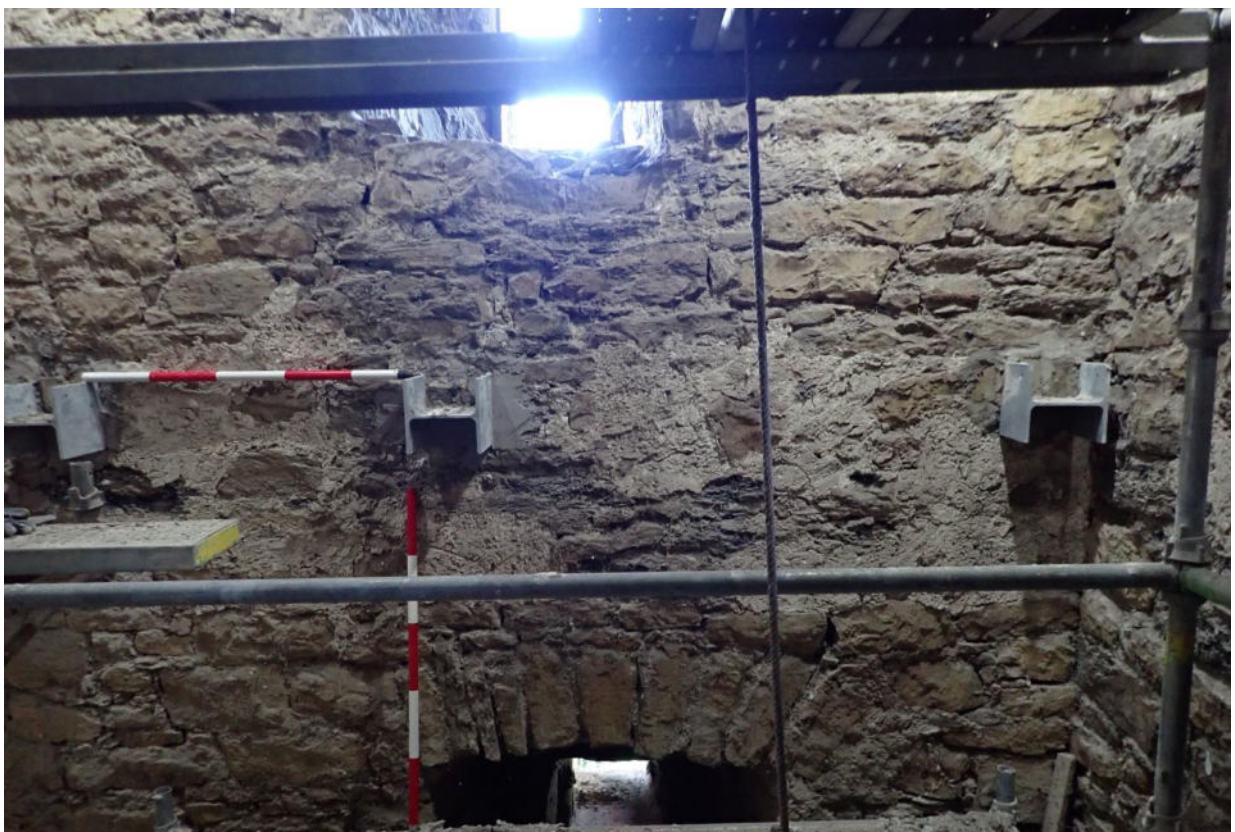
Plate 25: Second floor, west Wall, brackets from the centre to the NW corner.

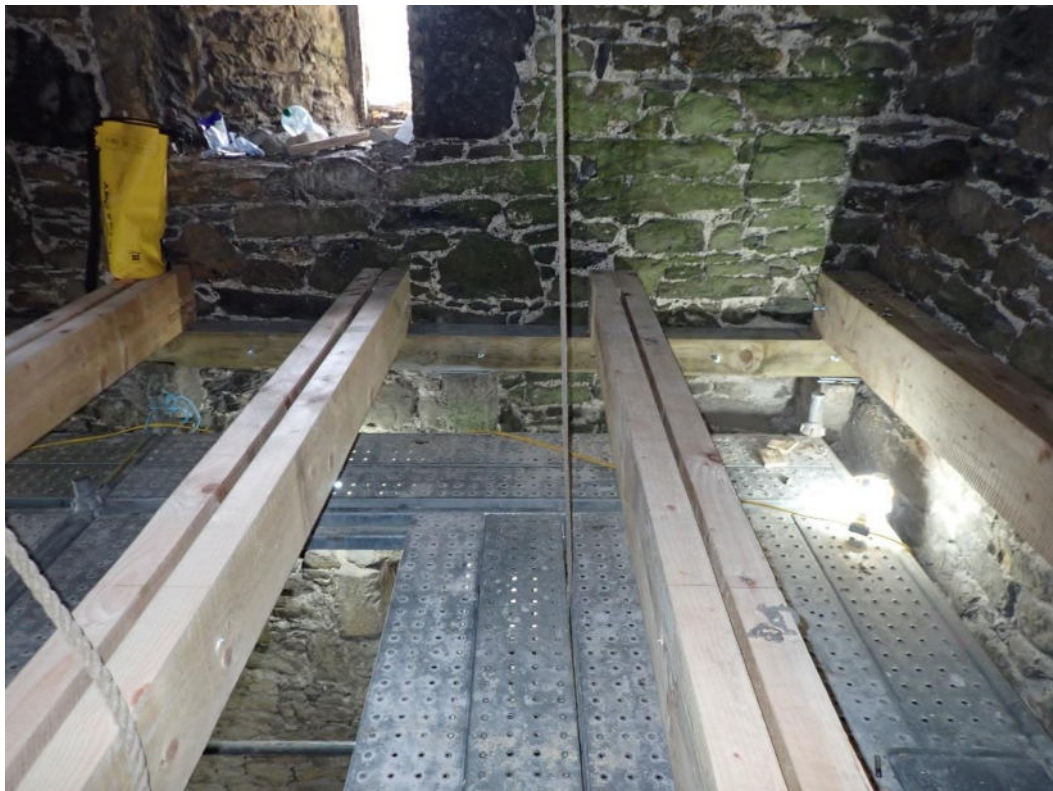
Plate 29: Beam over the corbels, east wall, with joists above.

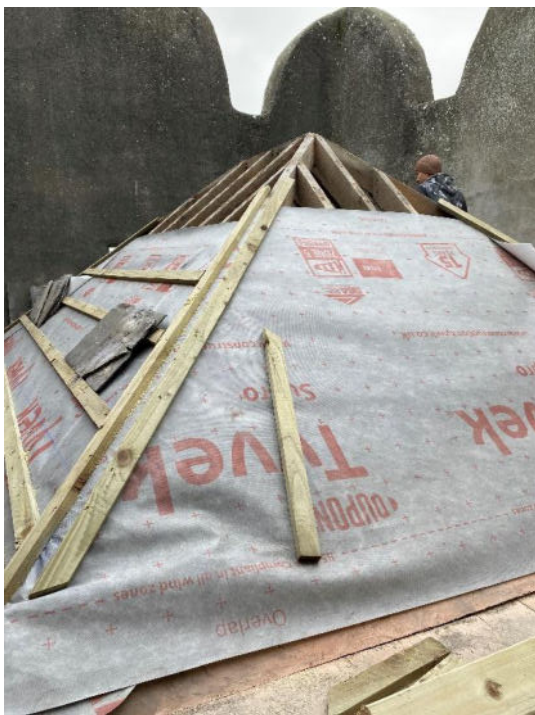
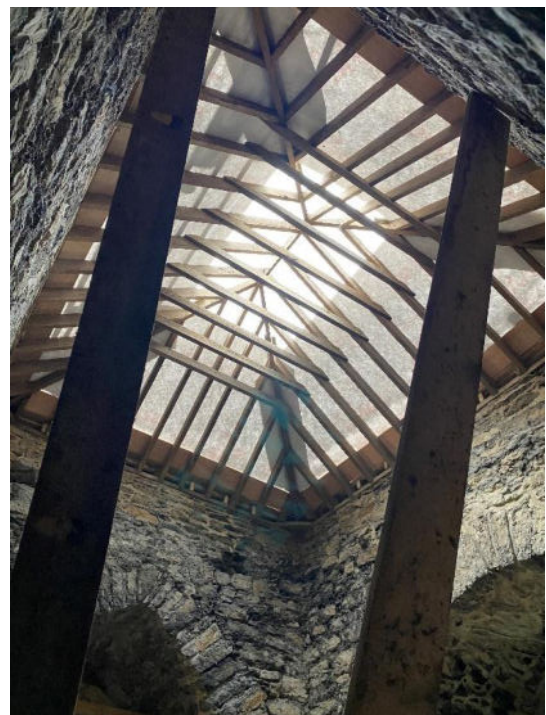
Plates 32-33: Slates removed.

The existing slipped and damaged slates to be re-fixed and replaced with matching natural slate where beyond use. A new raised flat gutter will be formed with timber and stainless-steel grounds set above the original stone gutter. The new gutter will be covered in walking grade pvc membrane dressed under the slate roof and with a new upstand formed against the rendered inner face of the parapet. The new gutter will protect the original stone gutter. The original outlets will provide ventilation to the new gutter. A new fabricated outlet spout in stainless steel will discharge through one of the existing gutter outlets beyond the face of tower.

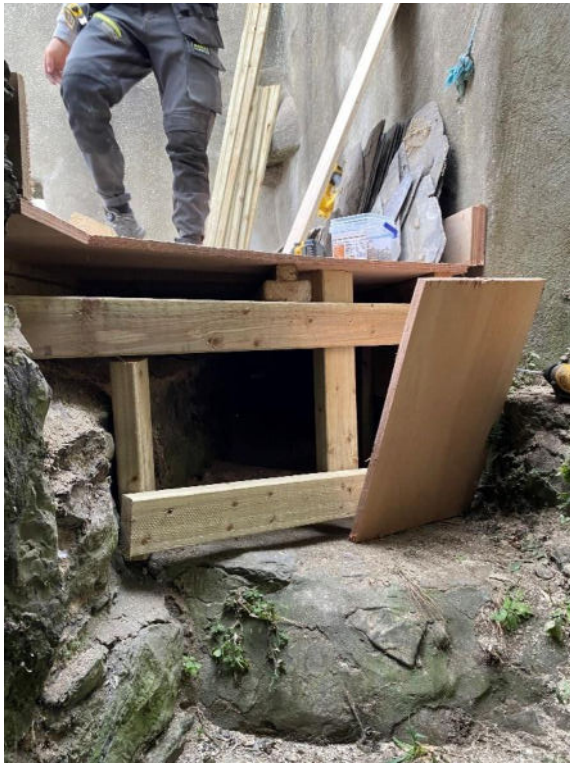
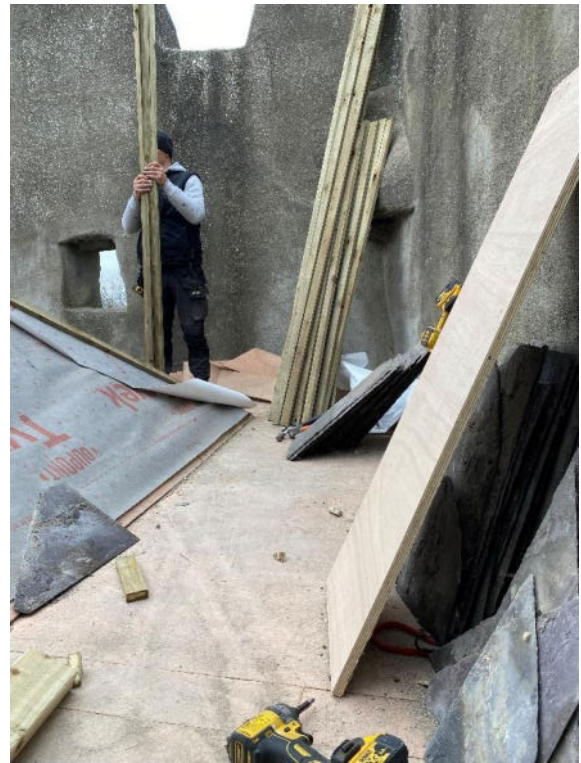
Plates: 34-35: Work in progress.

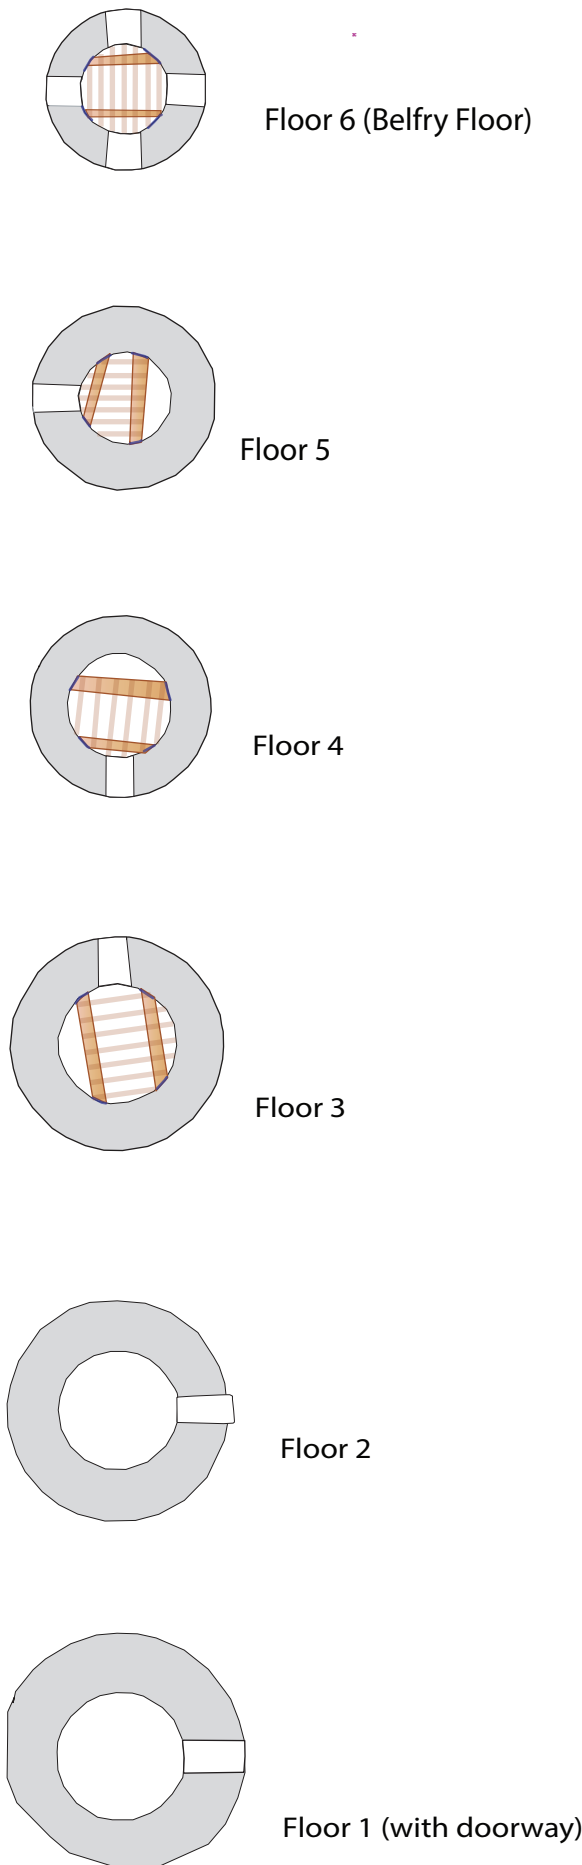
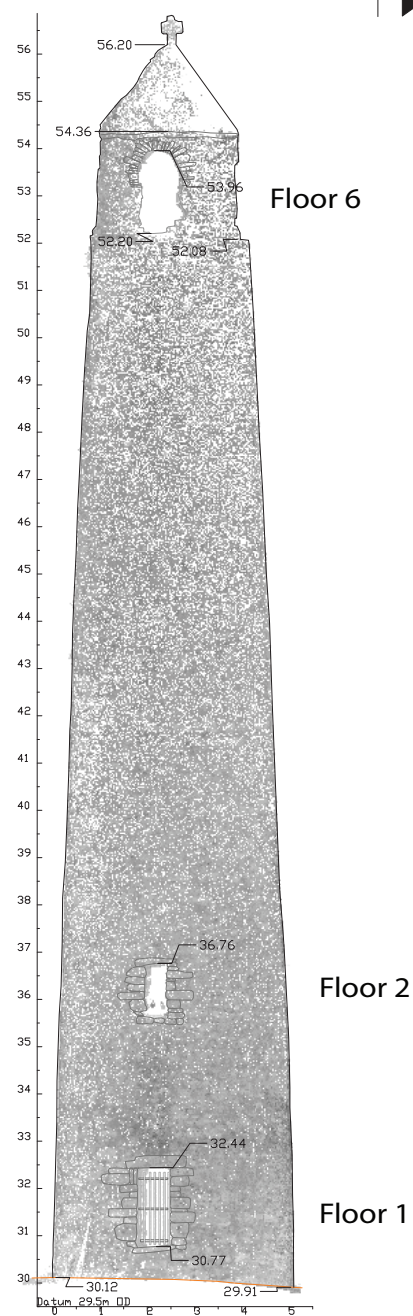
Figure 2: Plan of round tower showing original wooden floors and location of beam holes

The manner in which the six levels were floored, and how access to them was managed was not understood, but examination of the beam holes surviving at the various levels allows an interpretation of how the floors were placed (see Figure 2). It is possible that the floor at the entrance level was complete and rested on a ledge in the wall. Traces of such a ledge are visible, but in reality, they are very irregular. The so-called Treasury floor, Floor 2, has corbelling around its perimeter. It is not known how the remainder was floored, whether the corbelled stone continued, or there was a wooden insert. It is likely that the access to Floor 2 was by means of a ladder through the centre of this floor.
